**DELTA VEHICLE
FLIGHT FAILURE REPORT
LAUNCH 33**

OCTOBER 1966

**GODDARD SPACE FLIGHT CENTER
GREENBELT, MARYLAND**

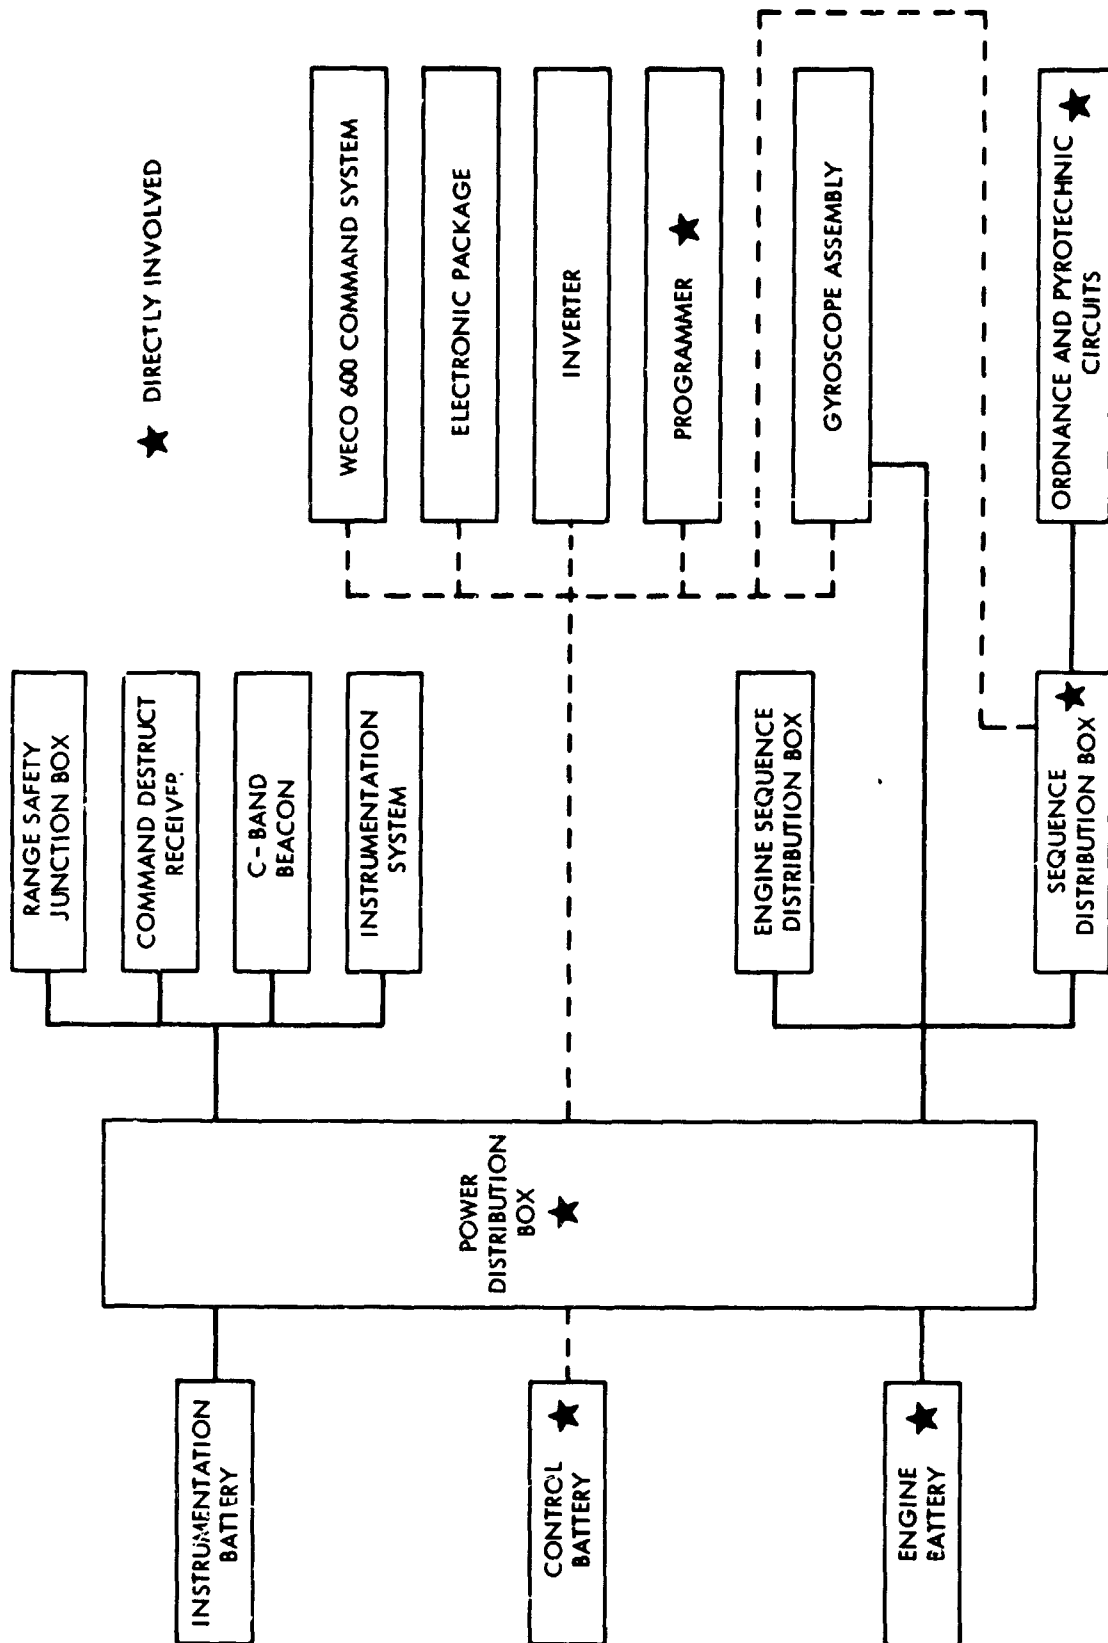
Figure C-1. Electrical System

- d. The programmer then provides the commands at pre-set times for the second stage sequences.
- e. The second stage programmer, which was started at first stage main engine cutoff (MECO), applies the negative (ground) side of the Control Battery to the coil of relay K703 at the programmed time for the sequence 4 event (based on mission requirements). Control Battery positive is available from lift-off.

- f. Relay K703 is "locked in" through one set of its contacts and applies Engine Battery voltage through two (2) sets of its contacts to parallel circuits composed of the redundant bridge wires and squib switches of sequence 4 ordnance/pyrotechnic items. Each contact provides for all

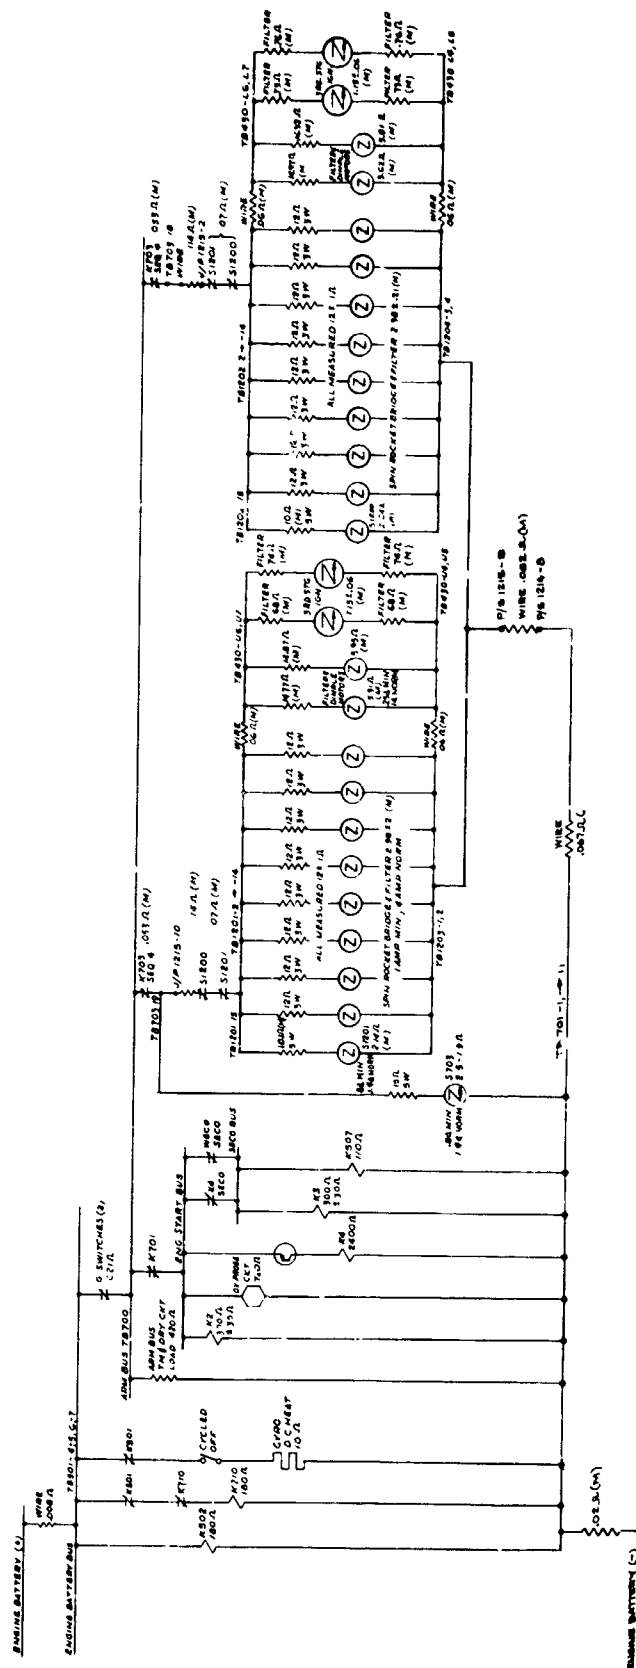
Figure C-3. Sequence 4 Engine Battery Circuit

by resistors. The values selected approximate the DC resistance of ordnance/filter combinations as shown on Figure C-3.

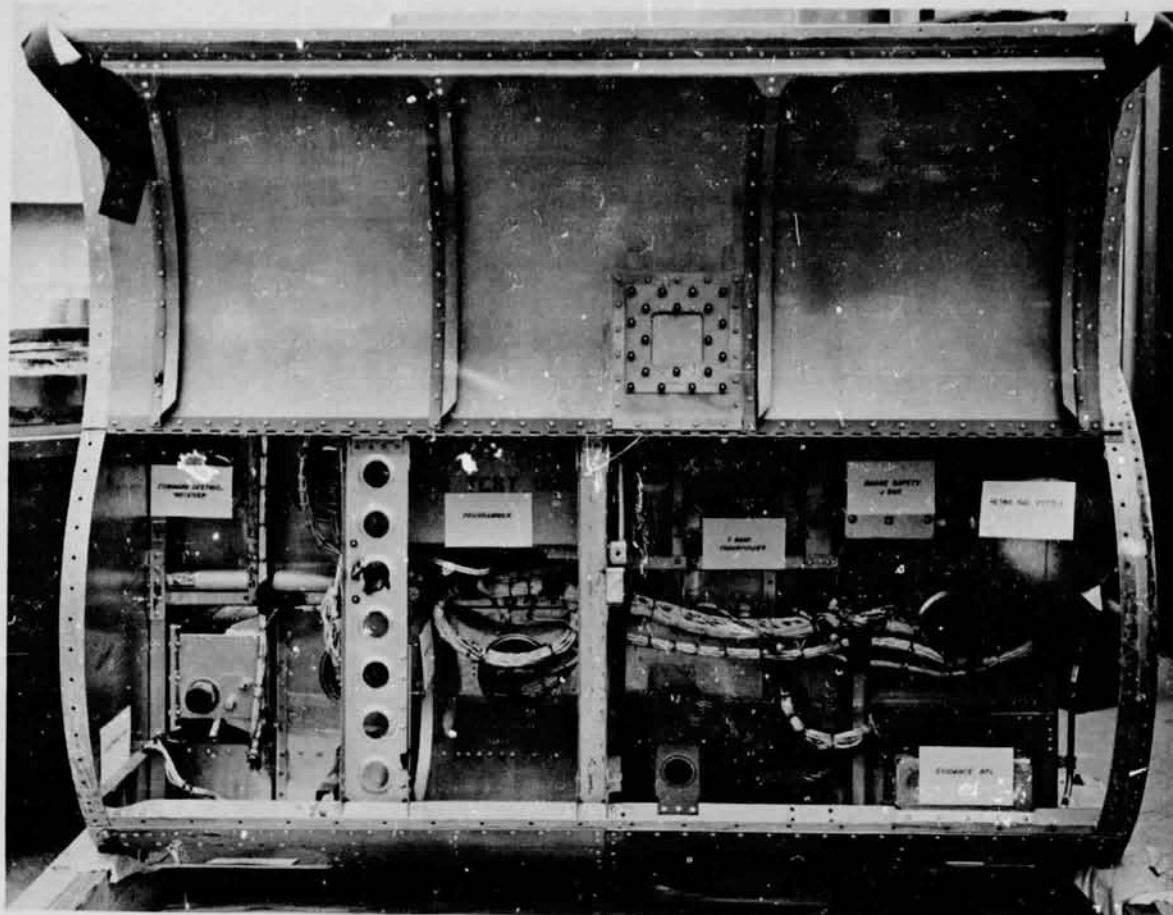
Figure C-4. Second Stage Mock-up

Mock-up Description: The mock-up consisted of Sections A and B. Section A was a DSV-3C second stage equipment compartment section as shown in Figure C-4. Sequence 4 circuitry including programmer, sequence J-box, engine battery, spin tube and wiring was installed. Section B, shown in Figure C-5, consisted of a flight qualified interstage, an X-258 dummy motor case, a flight qualified attach fitting, and third stage instrumentation. Sequence 4 circuitry was complete except for ordnance items and most R. F. filters. These were simulated

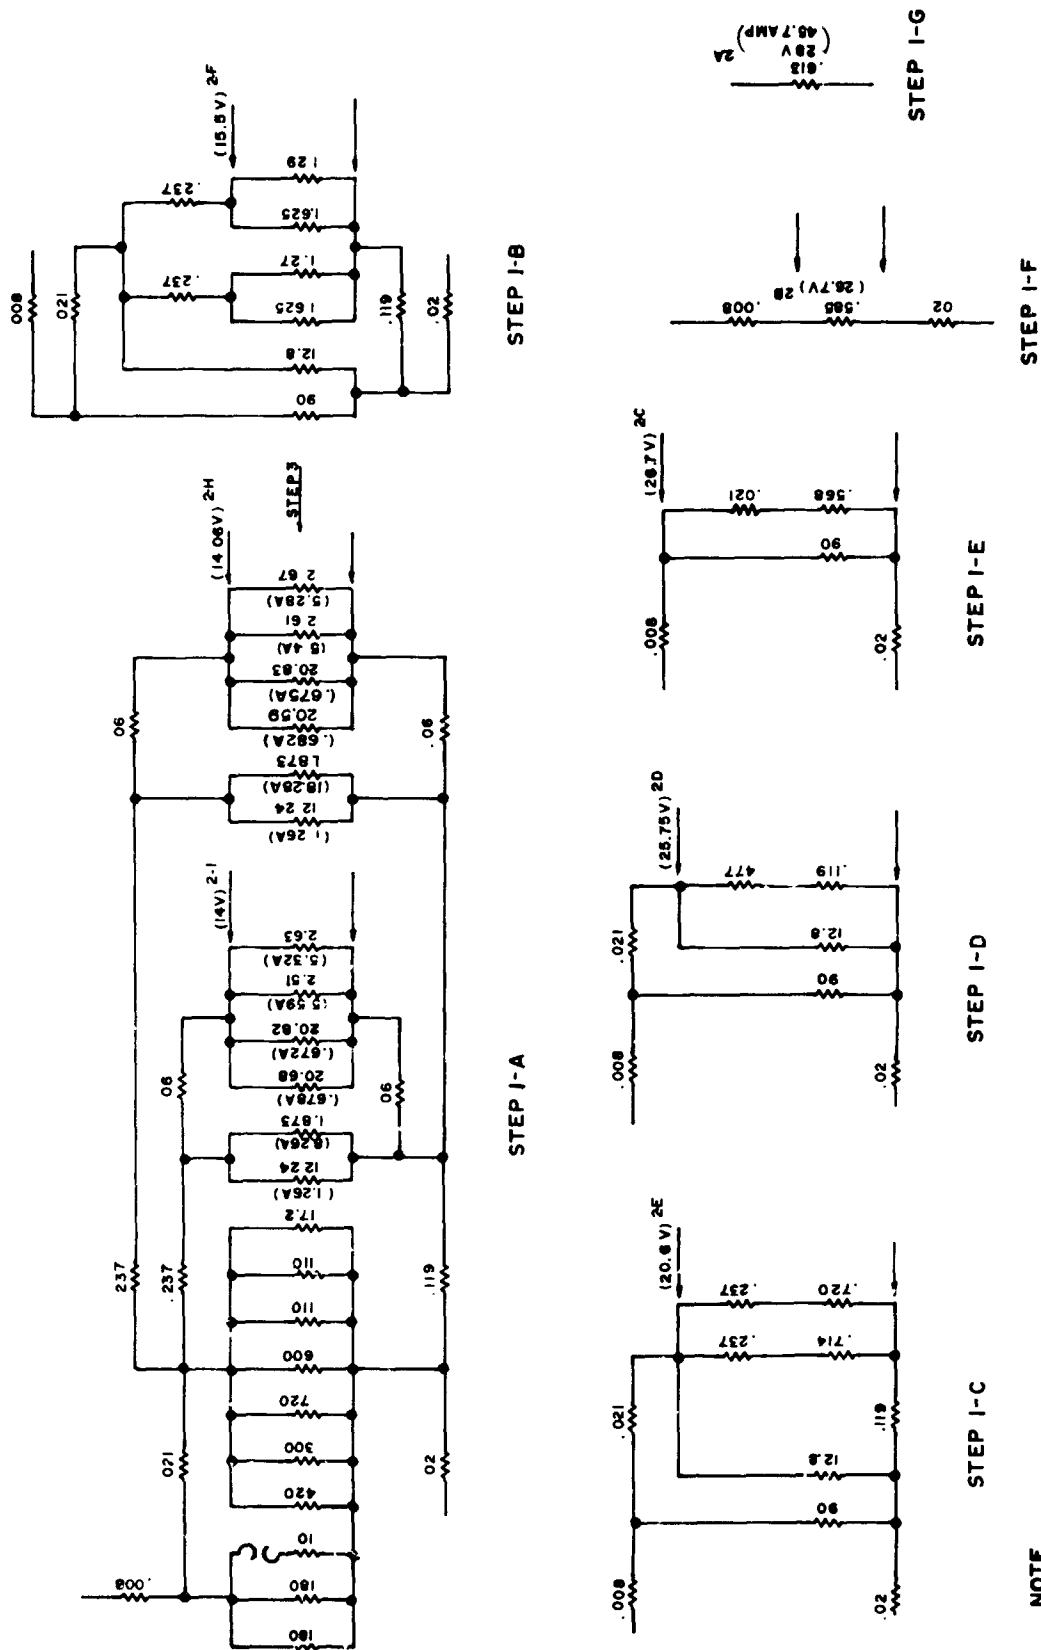
Figure C-11. Sequence 4 Initial Current Flow-Normal Operation

The load on the engine battery at sequence 4 was calculated to determine the total current available from the battery. The current distribution was determined from this quantity. Figures C-11 through C-13 depict the load for three conditions of the sequence relay K703. First is the normal operation in which all bridgewires are connected to the engine battery through two contacts of the relay. Then, operation of each contact of the relay is considered. These might correspond to a momentary closure or short circuit. These are summarized in Table C-5.

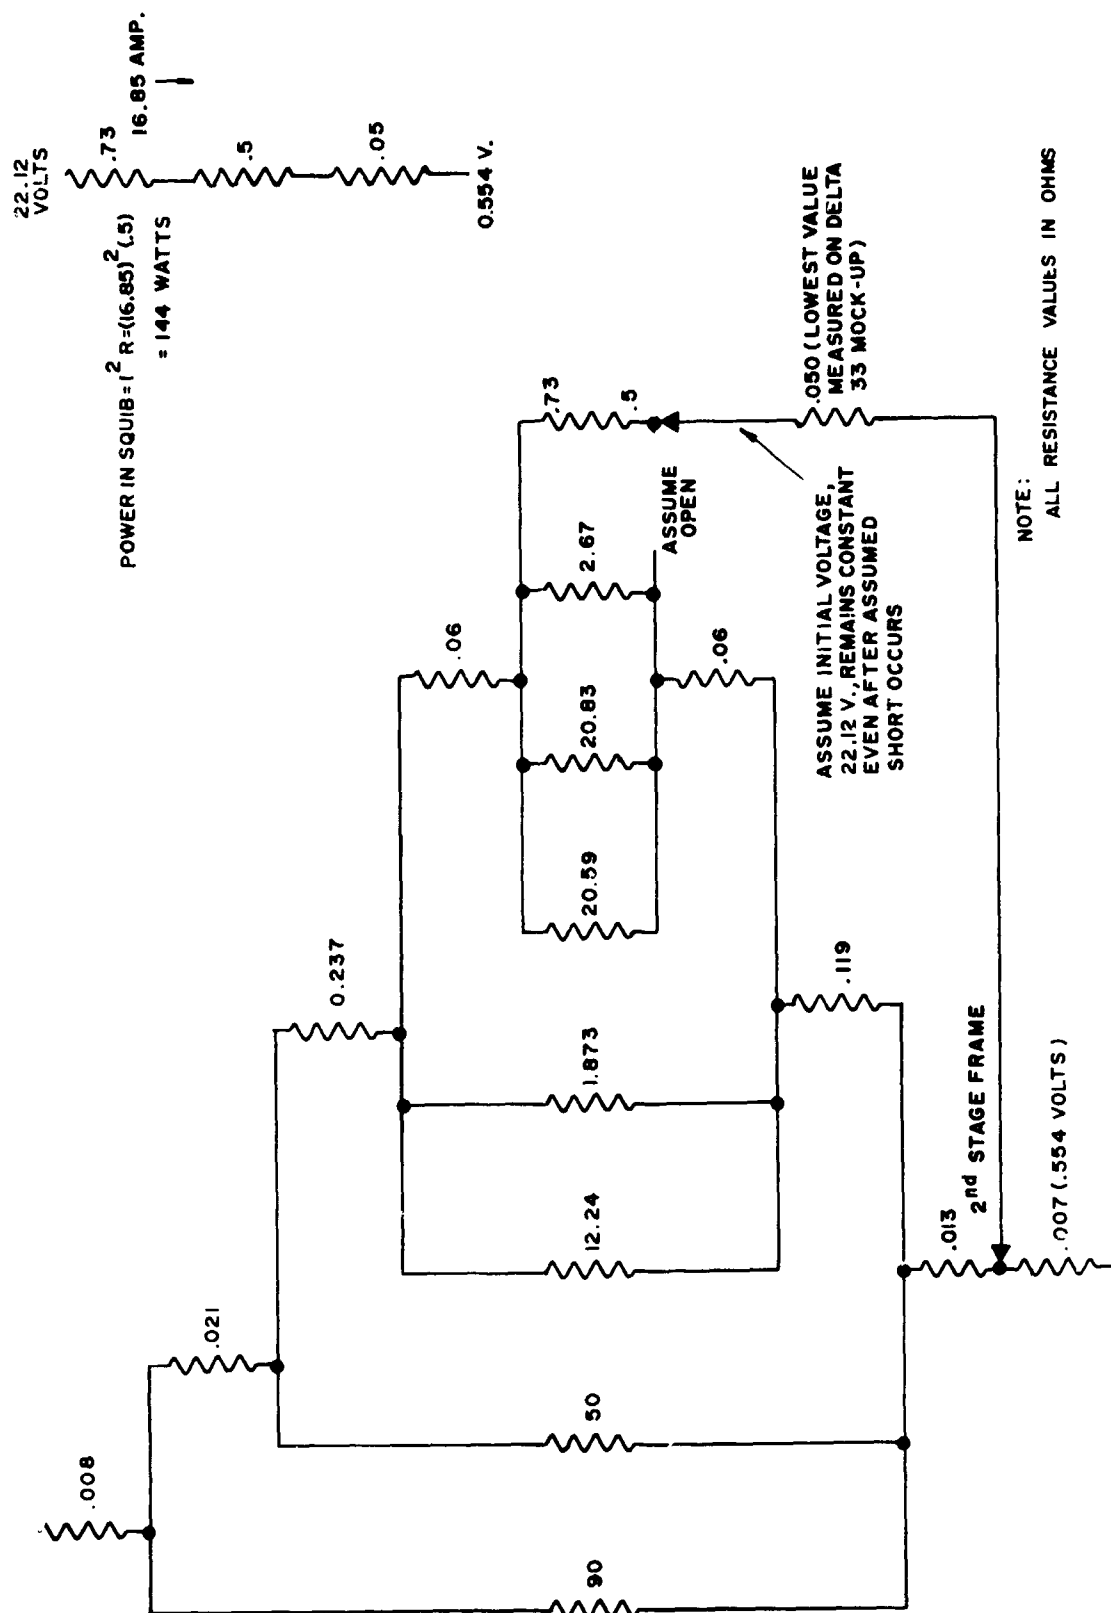
Figure C-14. Special Condition (Assumed Short to 3rd Stage Ground at Squib)

Three special conditions were considered to determine the power that might be dissipated in the SD60AO squib with various combinations of open and short circuits. Figures C-14, C-15 and C-16 show these connections.

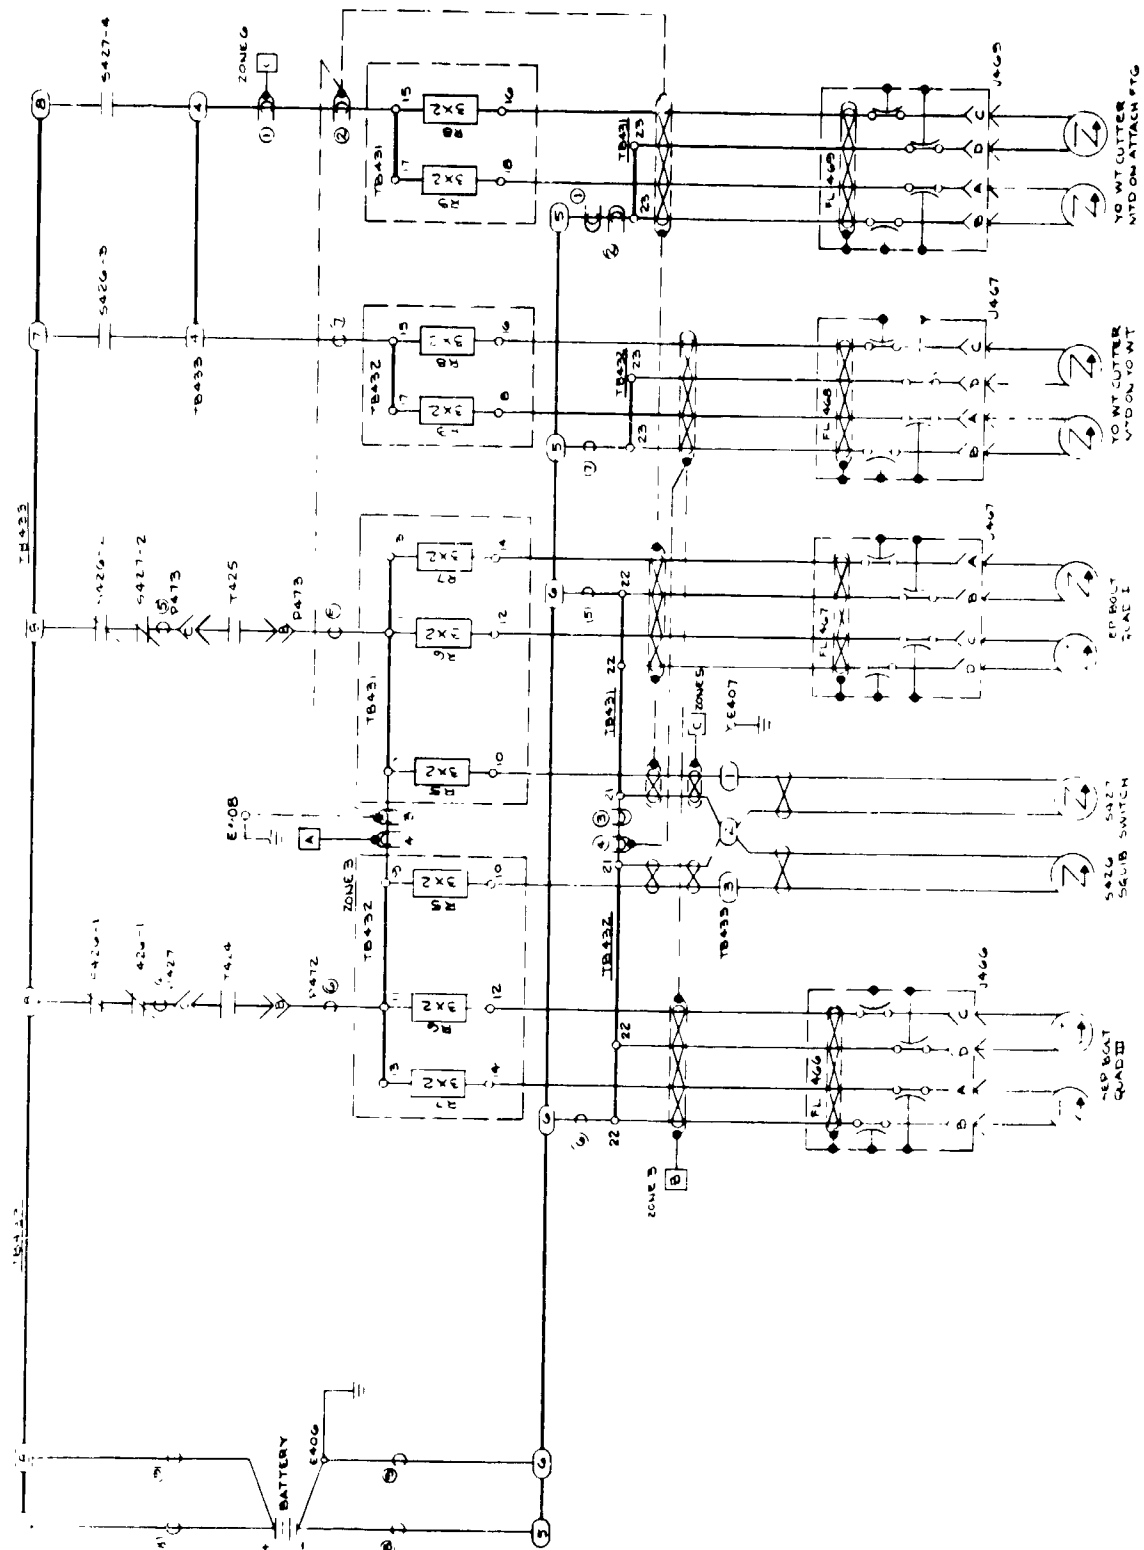
Figure C-18. Third Stage Schematic

A third phase in the examination of the electrical system was the distribution of current if the third stage battery should short to the sequence 4 circuit at some point on the attach fitting. The results are shown in Figure C-17, and indicate this to be an unlikely failure mode. The third stage schematic is provided as Figure C-18.
